R and **CENTER**
LABORATORY
TECHNICAL REPORT

NO. 12570

FAILURE ANALYSIS STUDIES OF T-142 TRACK PADS

JUN 1981

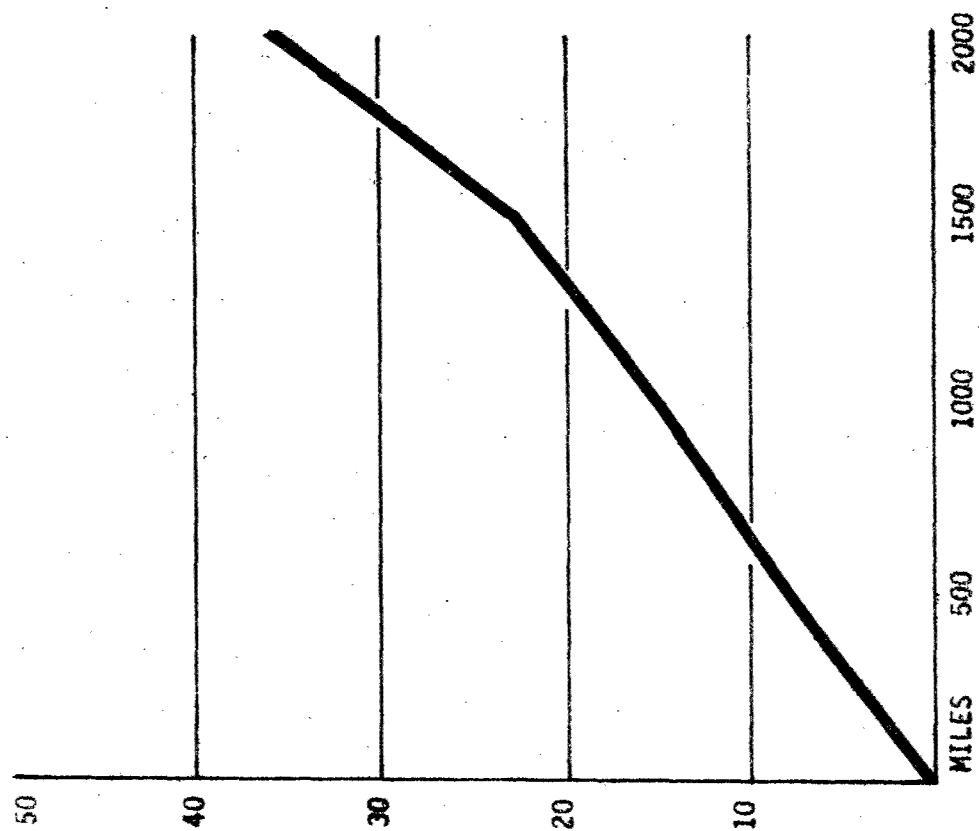
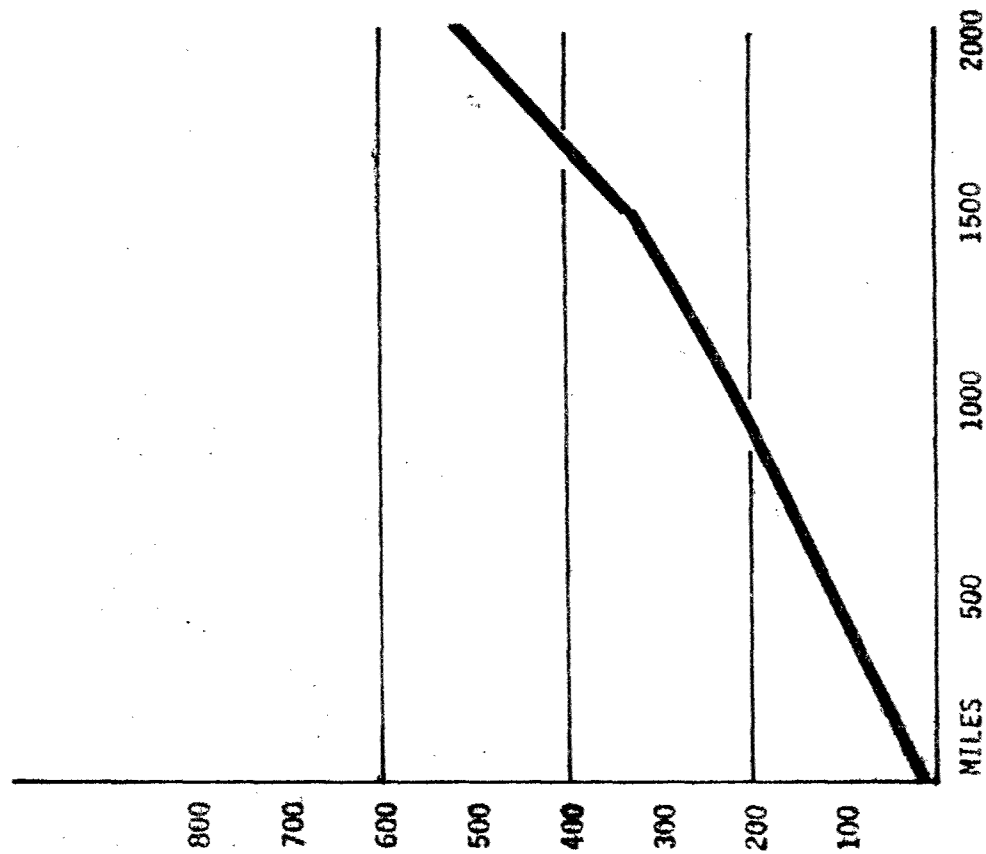
SET NUMBER 1

YUMA PAVED

1. Table #1 gives the comparative rating of all the sets for the three phases of the test.
2. Graphs #1-8 show each set individually graphed as to performance on the 2,000 mile paved road test. These graphs show the loss in grams from the pads and the percent loss at each weighing interval.
3. Graphs #9-16 show each set individually graphed as to performance on the 1,000 mile gravel road test. The weights and percents graphed represent the same type of information as those graphed on 1-8.
4. Graphs #17-25 show each set individually graphed as to performance on the 500 mile hilly cross-country test. These graphs show the same type of grams and percent information as the previous two categories.
5. Graphs #26-28 show the comparisons of each set of pads for the three phases. These graphs give a direct comparison of the percent of rubber lost by each set during each phase.

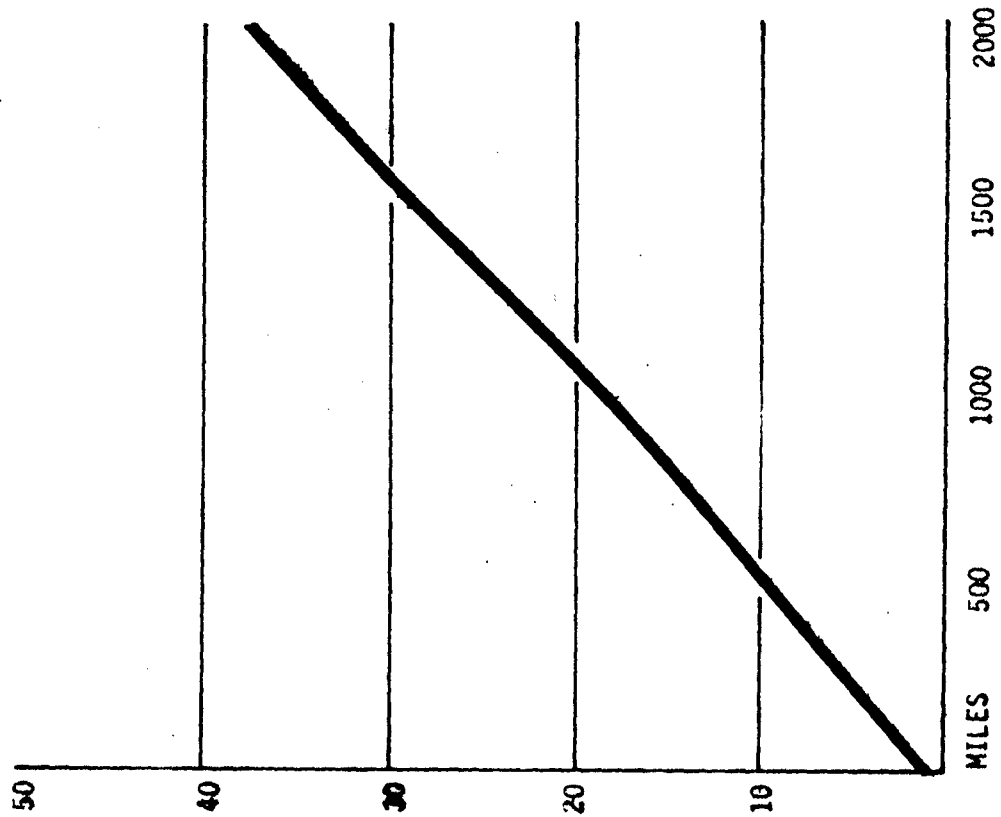
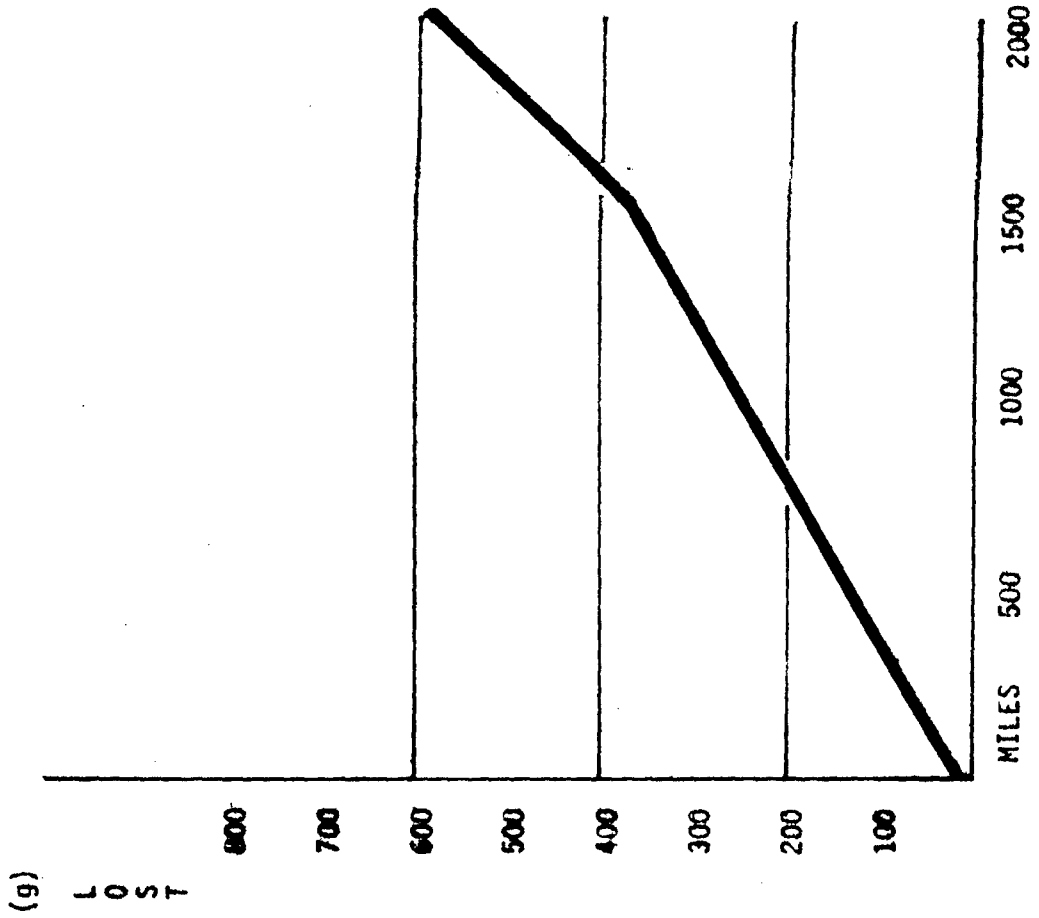
SET NUMBER 2

YUMA PAVED

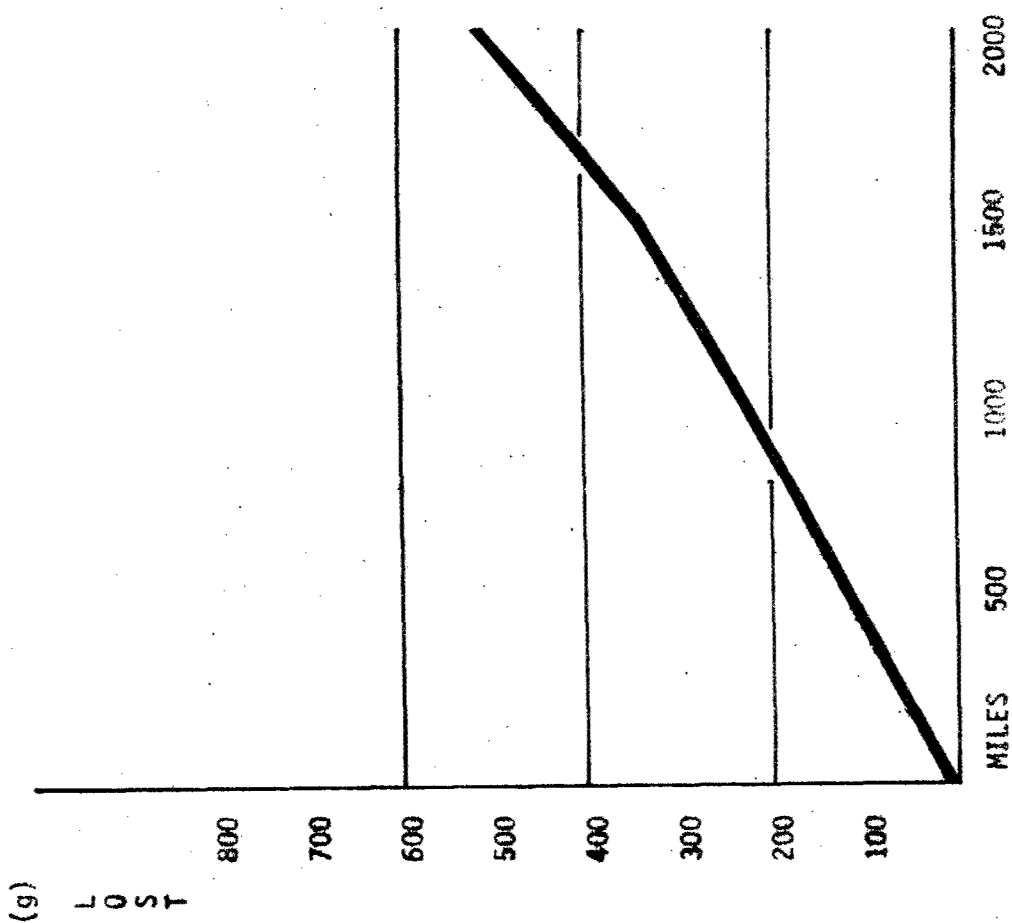
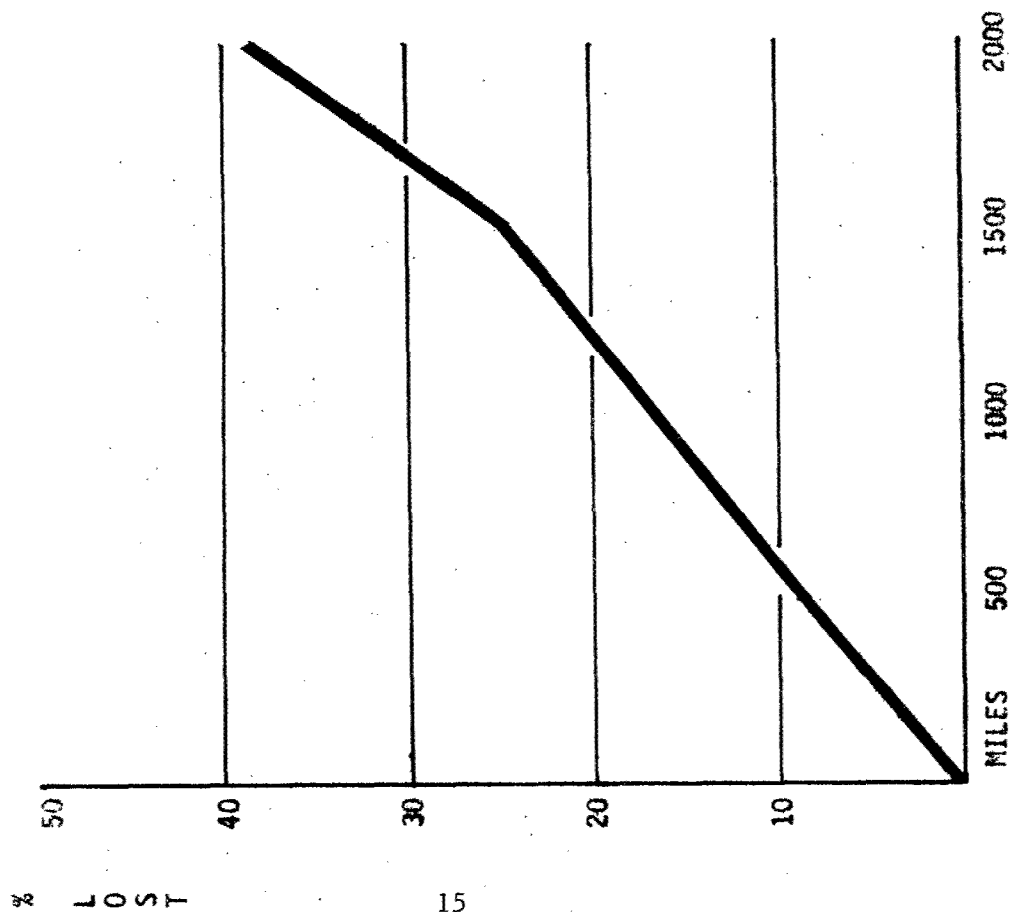
SET NUMBER 3

YUMA PAVED

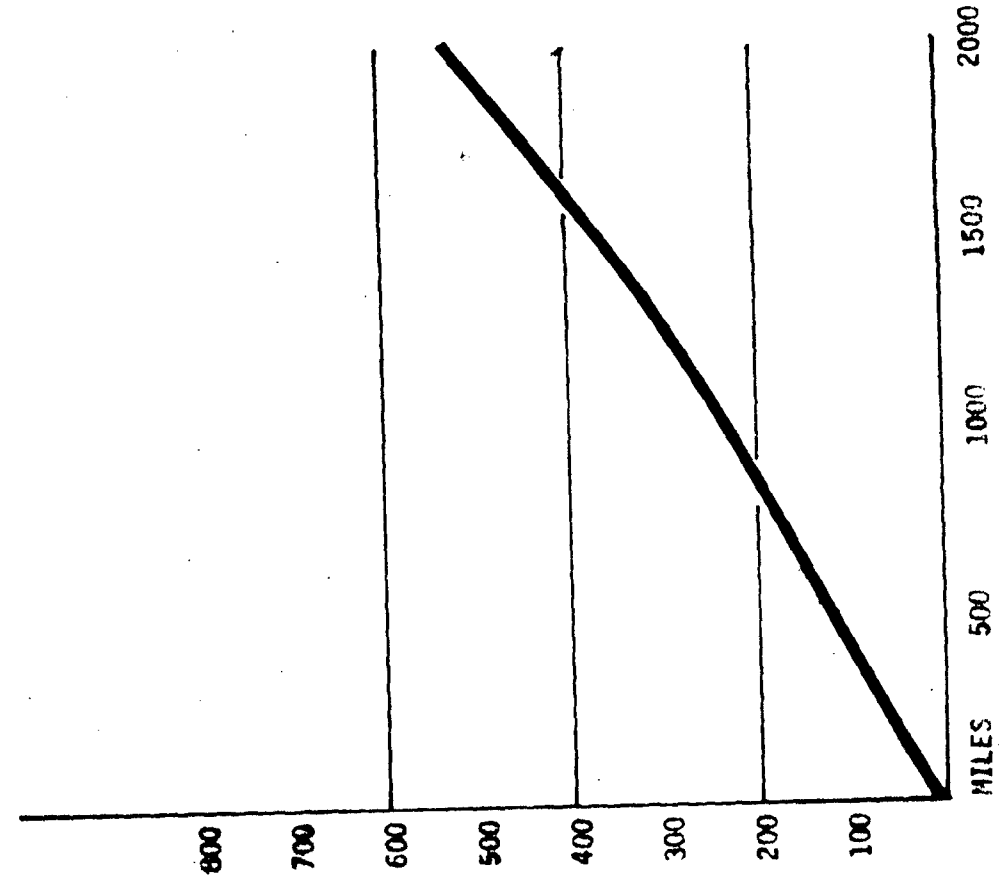
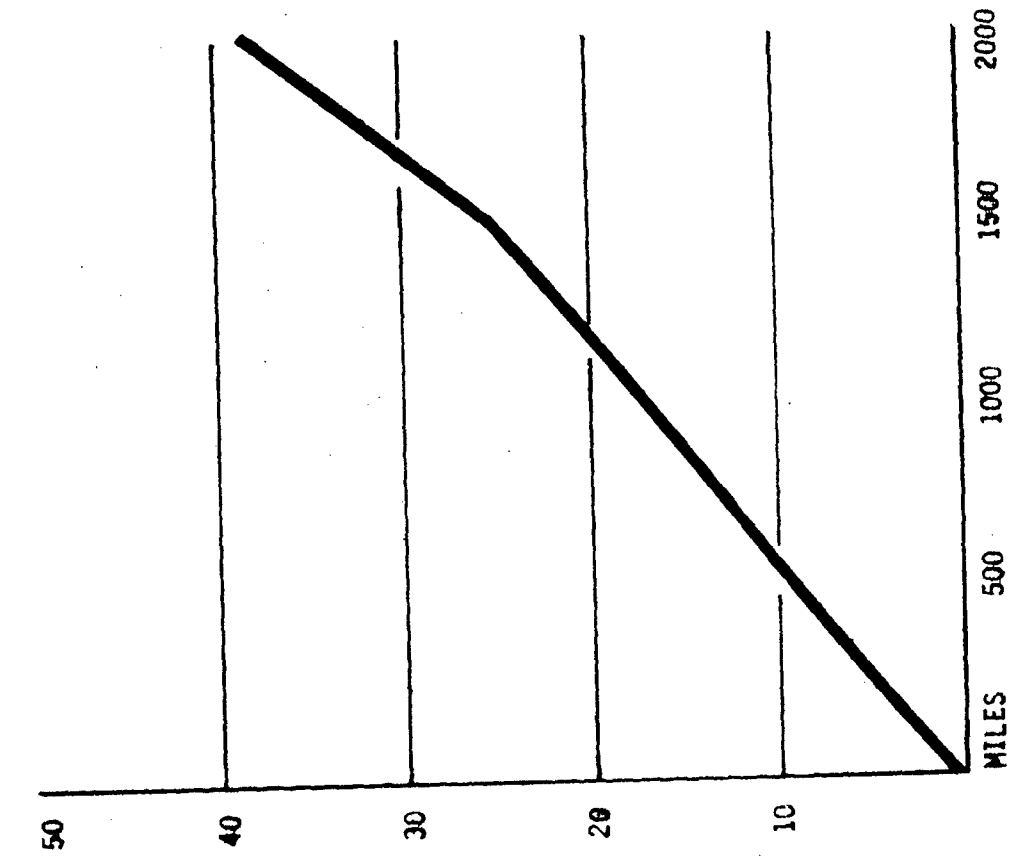
SET NUMBER 4

YUMA PAVED

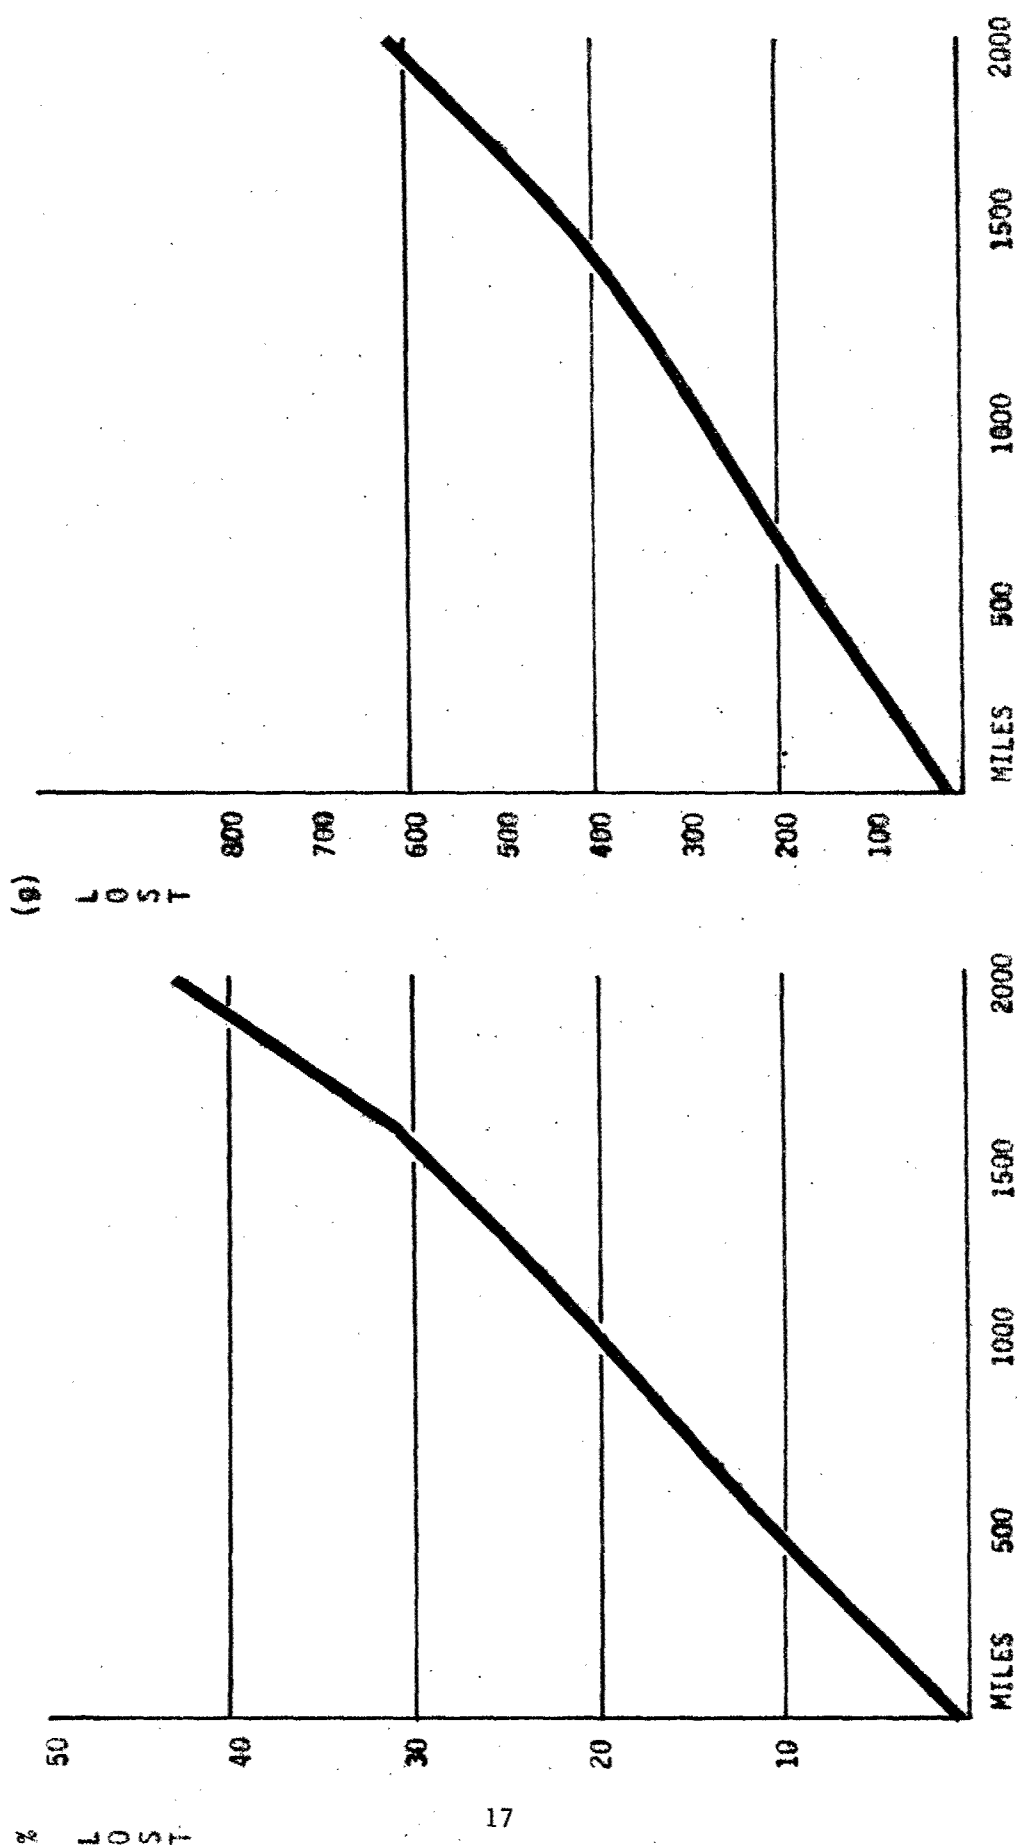
SET NUMBER 5

YUMA PAVED

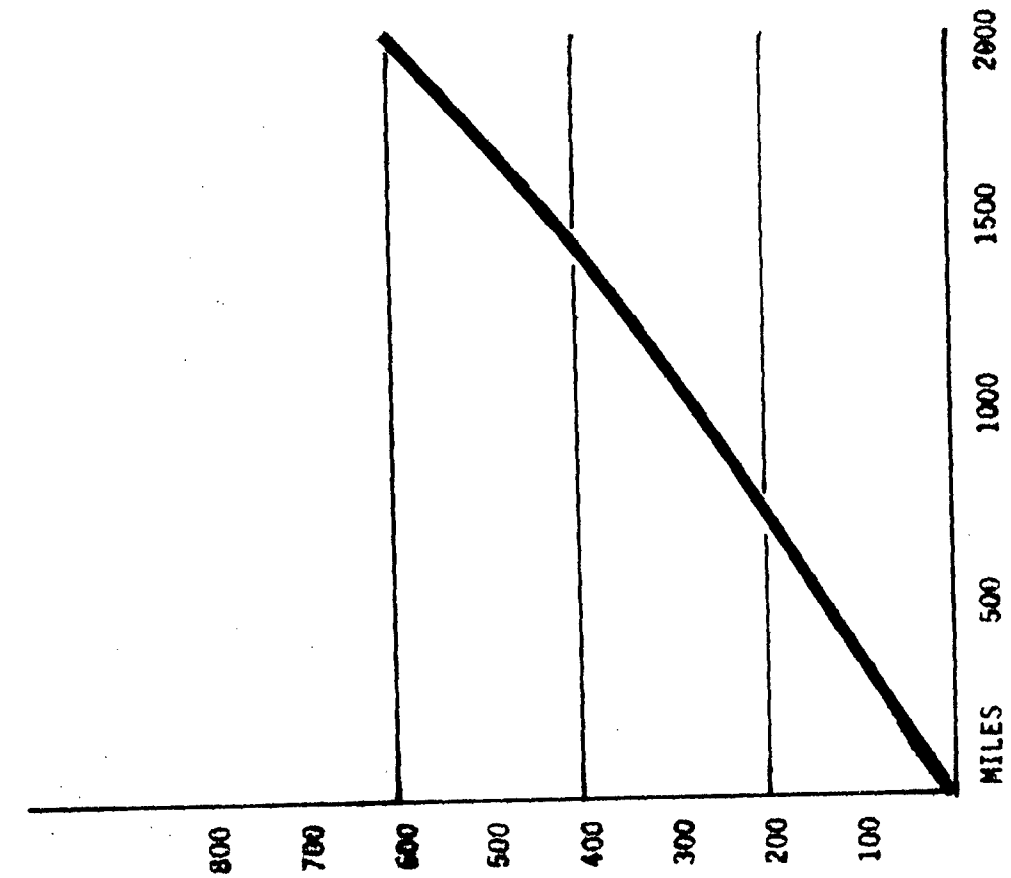
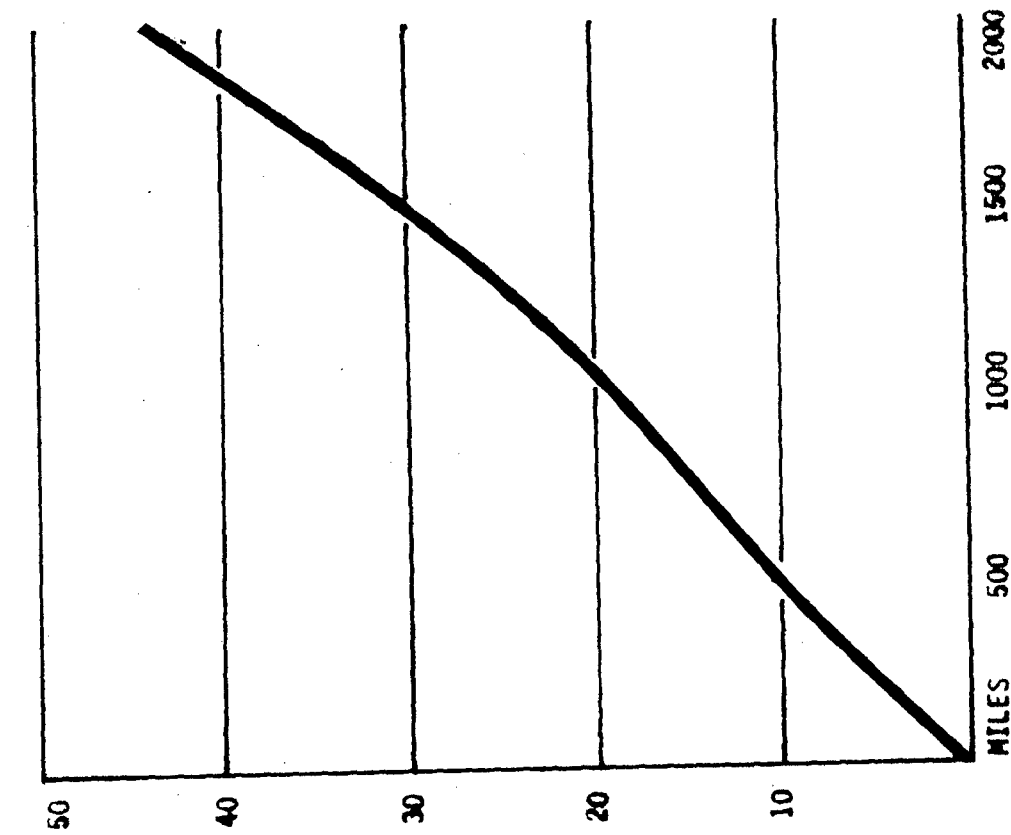
SET NUMBER 6

YUMA PAVED

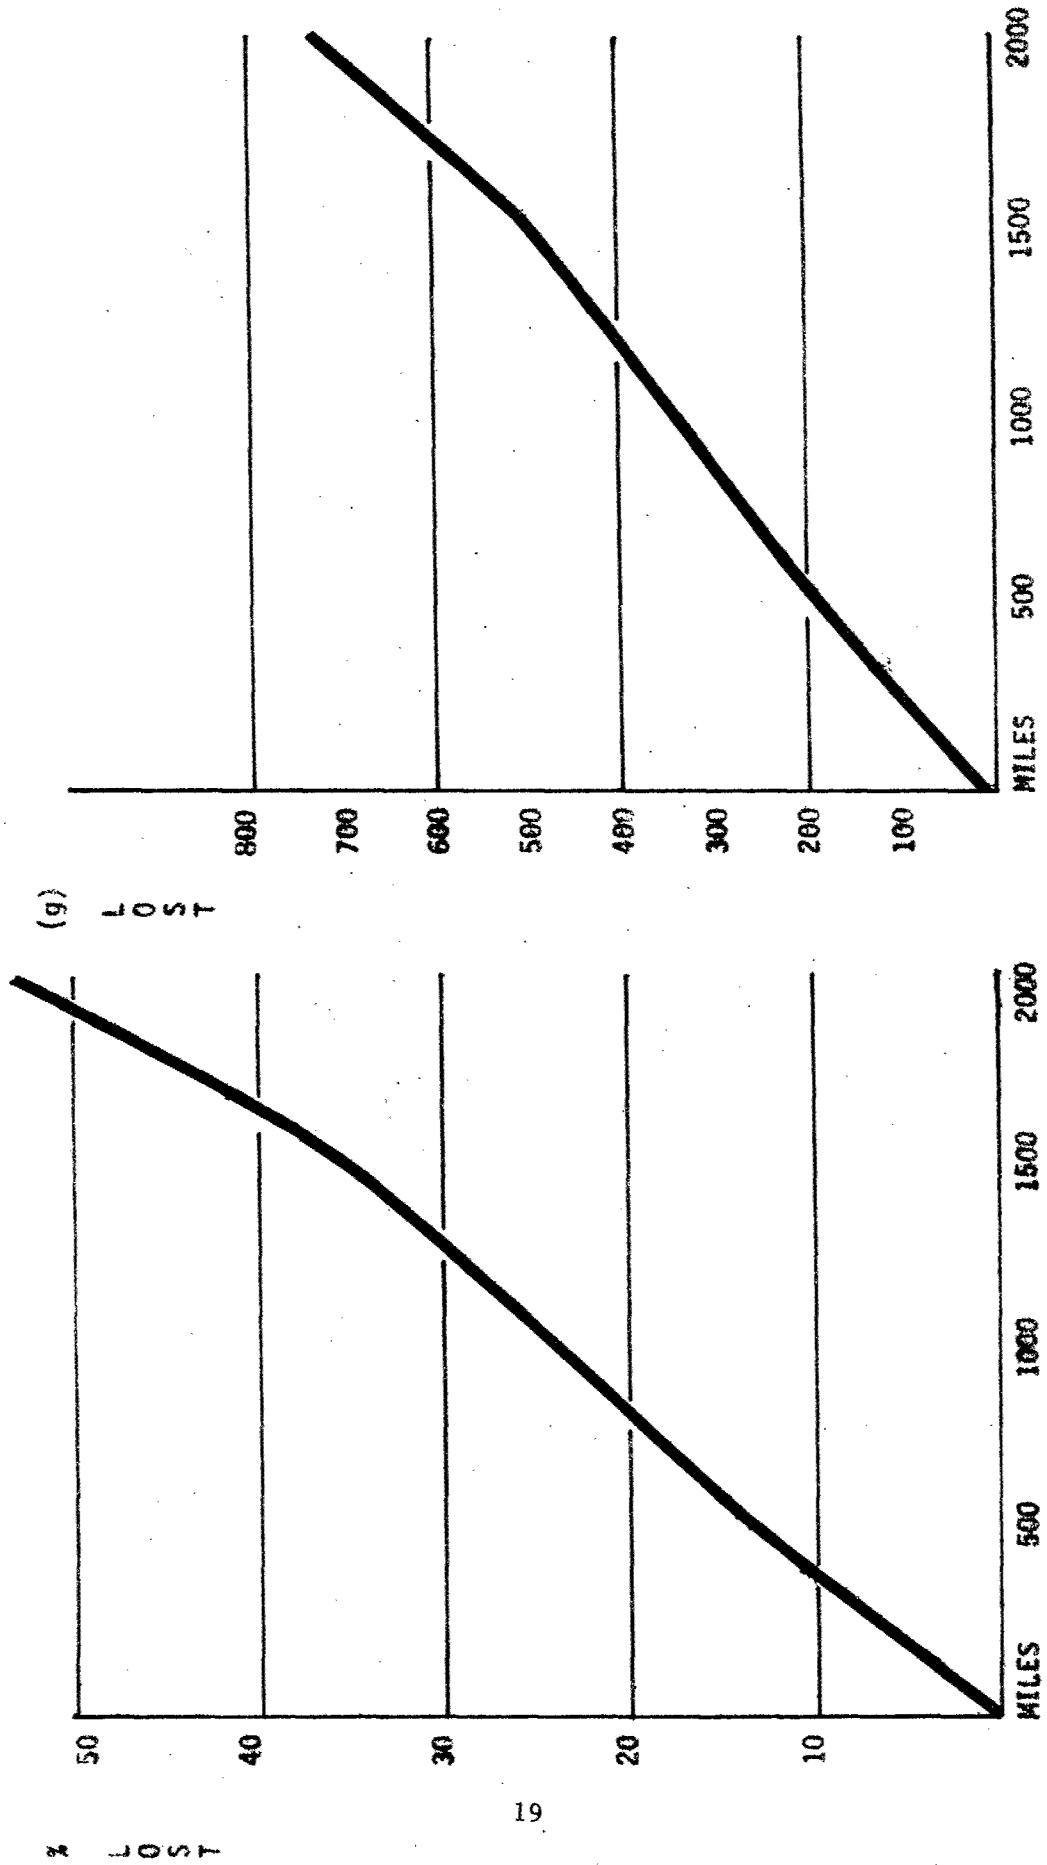
SET NUMBER 7

YUMA PAVED

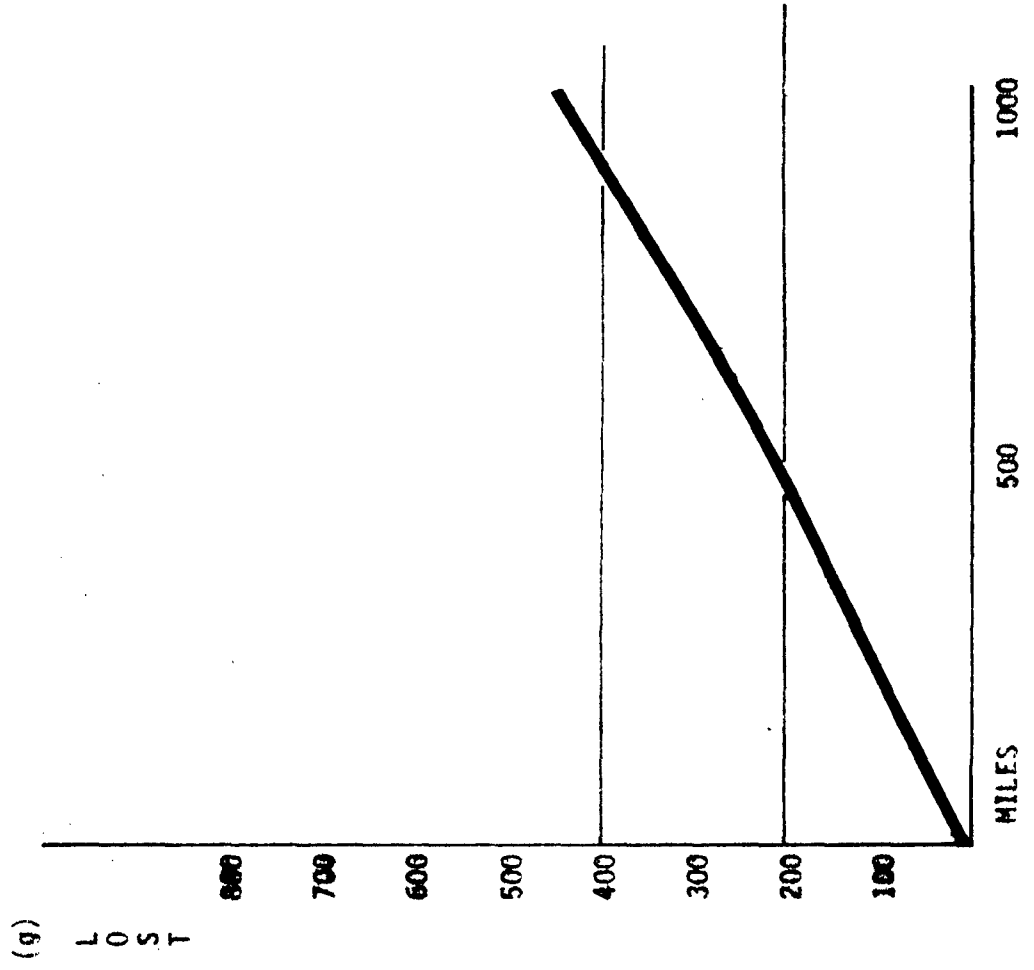
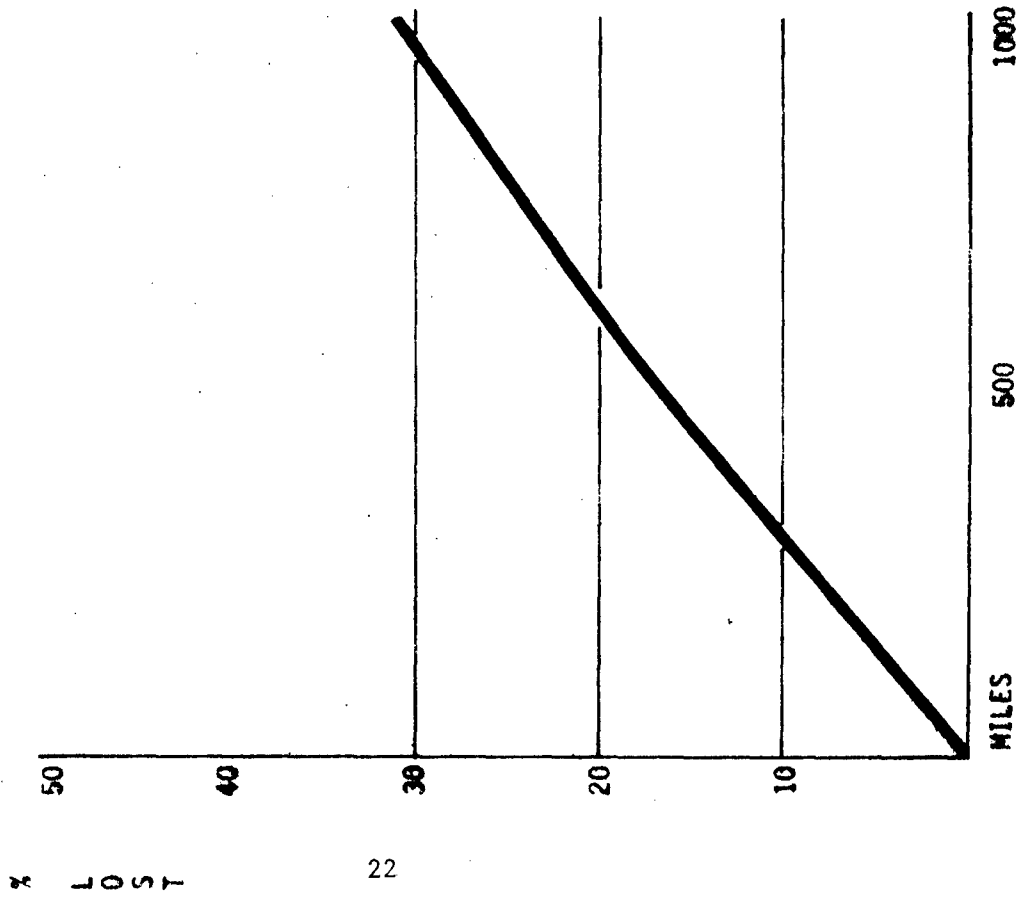
SET NUMBER 1

YUMA GRAVEL

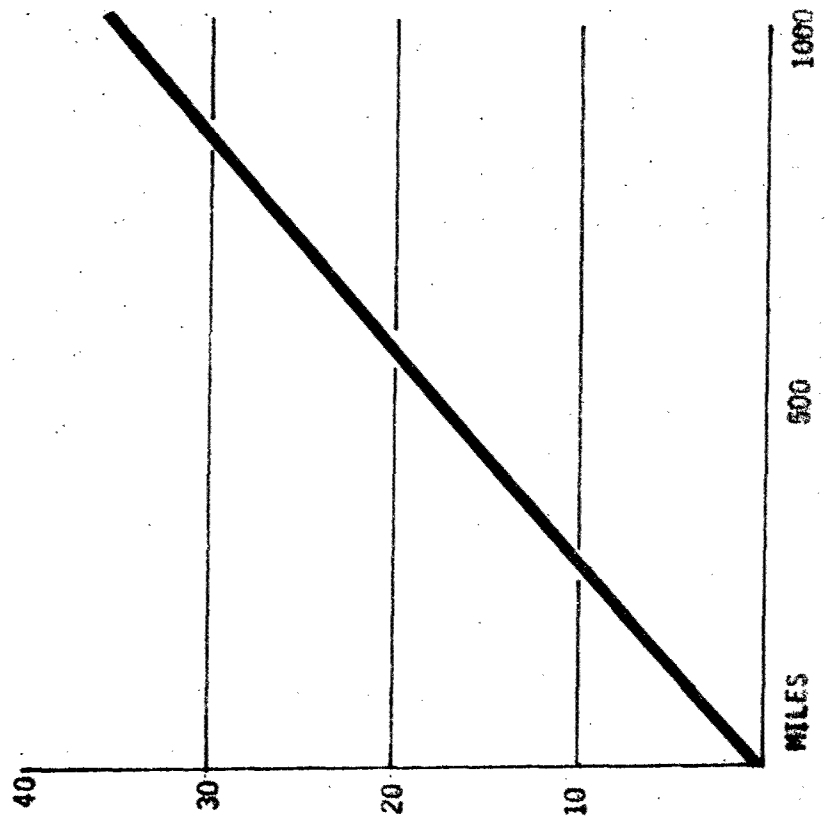
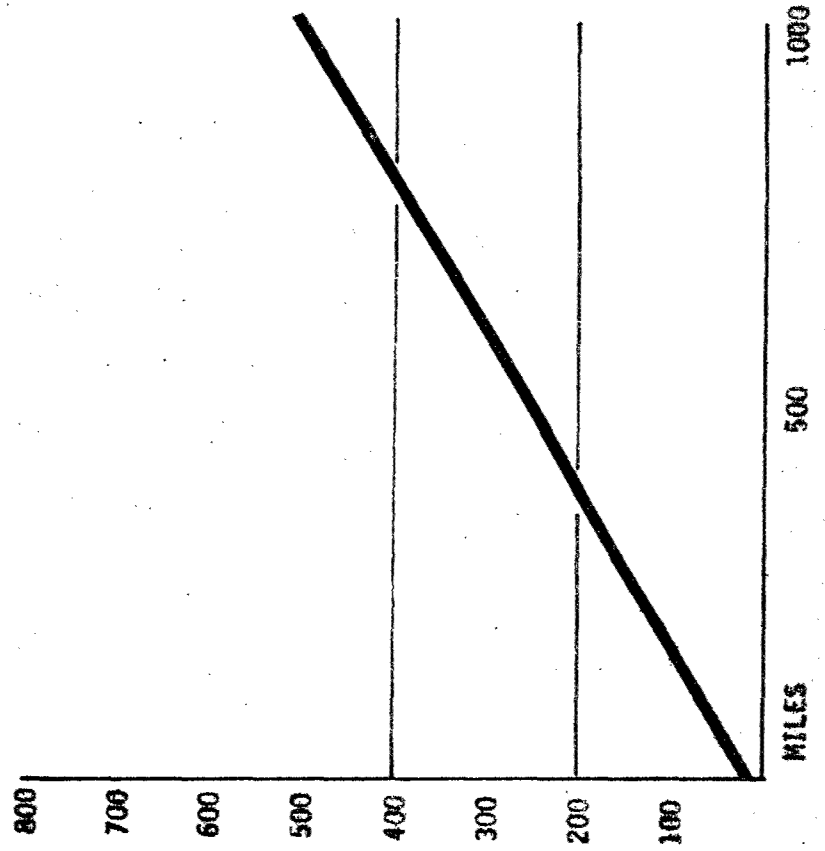
SET NUMBER 2

YUMA GRAVEL

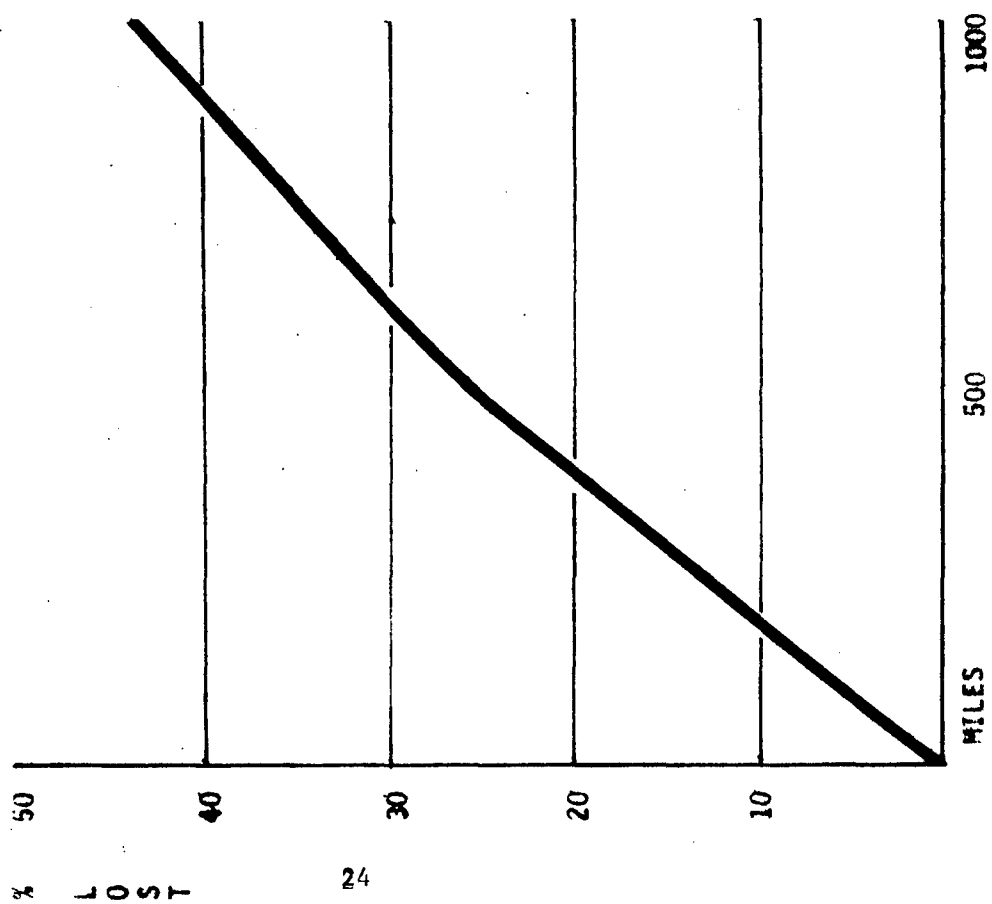
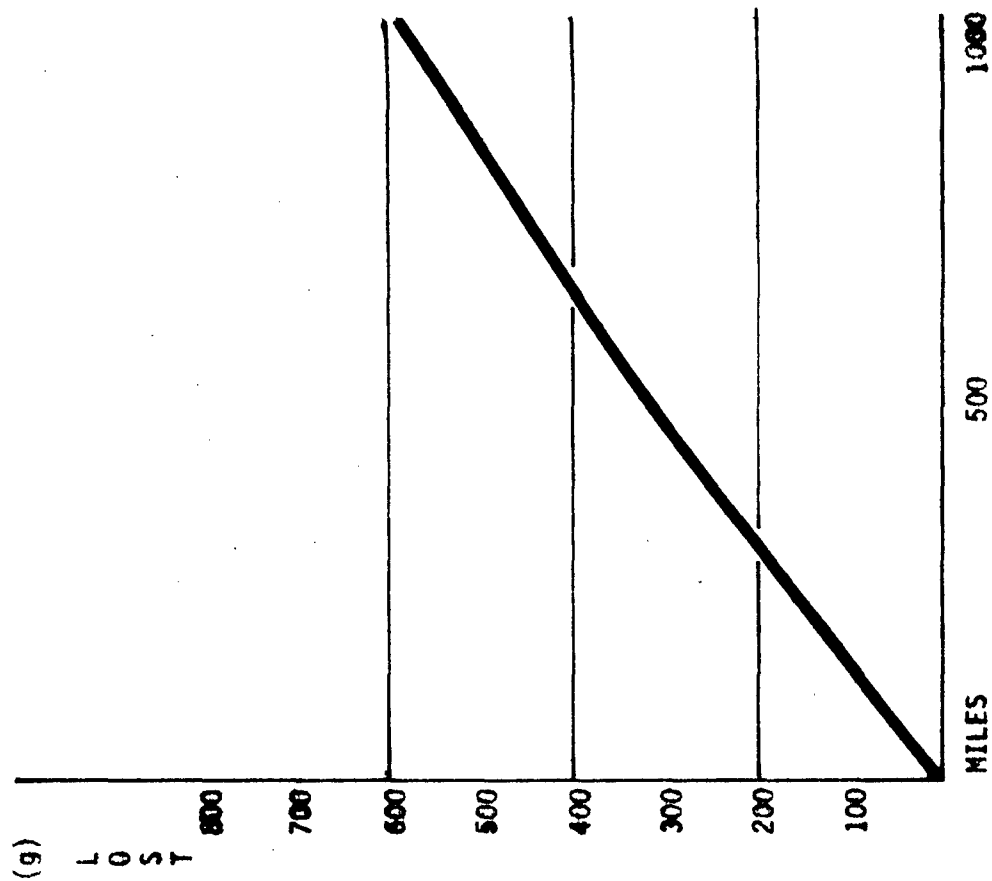
SET NUMBER 3

YUMA GRAVEL

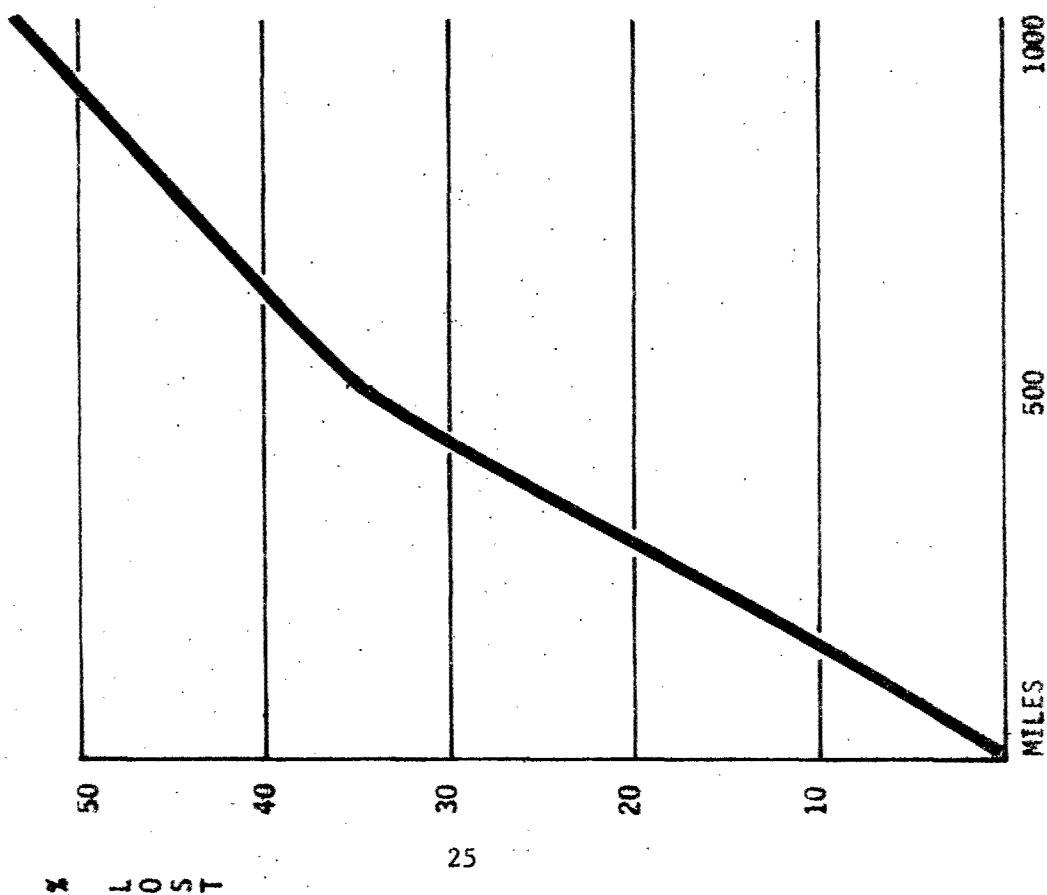
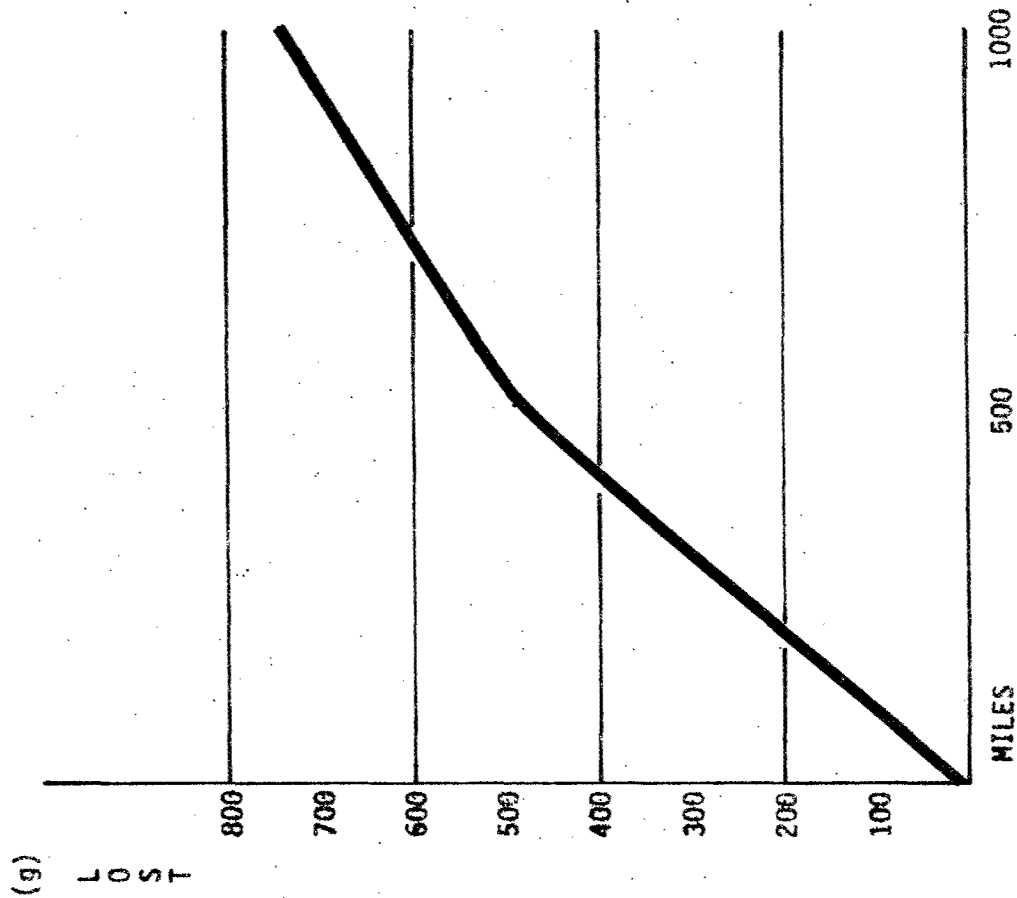
SET NUMBER 4

YUMA GRAVEL

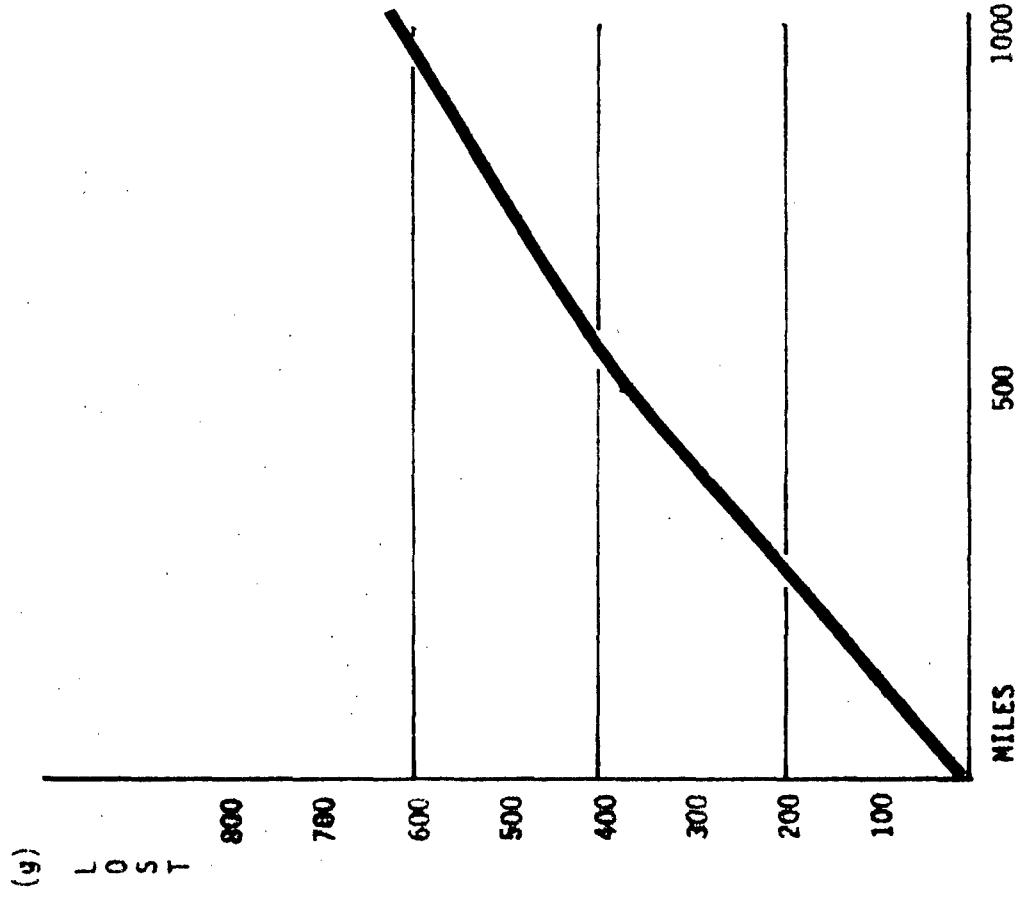
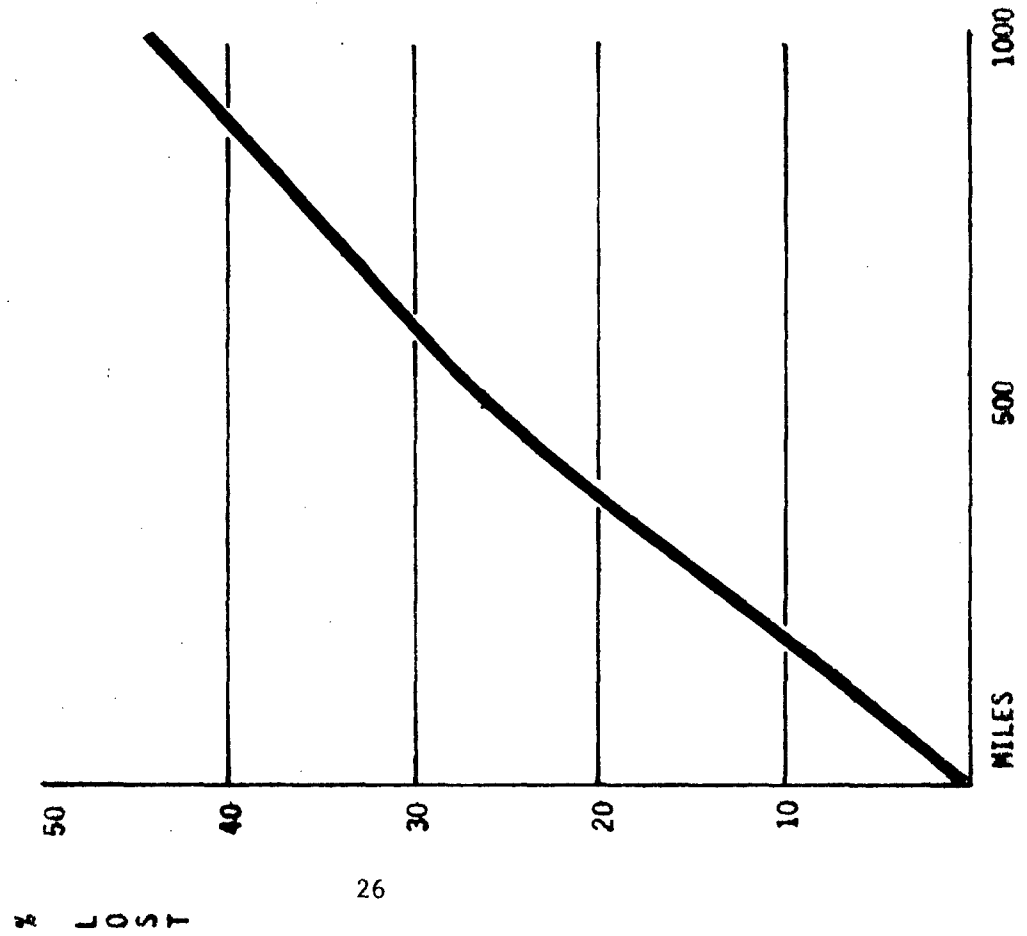
SET NUMBER 5

YUMA GRAVEL
